Raw Water Intake Vertical Column Pump Rebuild & Installation

Dubbo Case Study

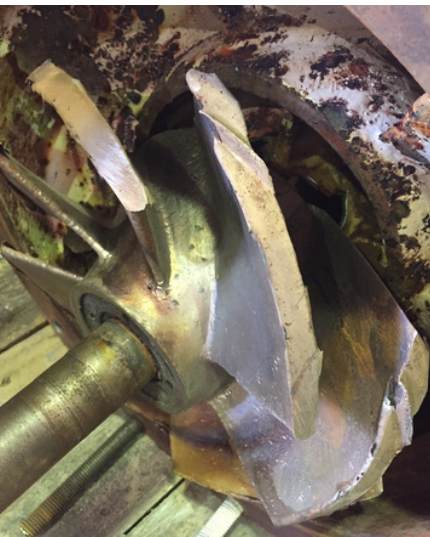
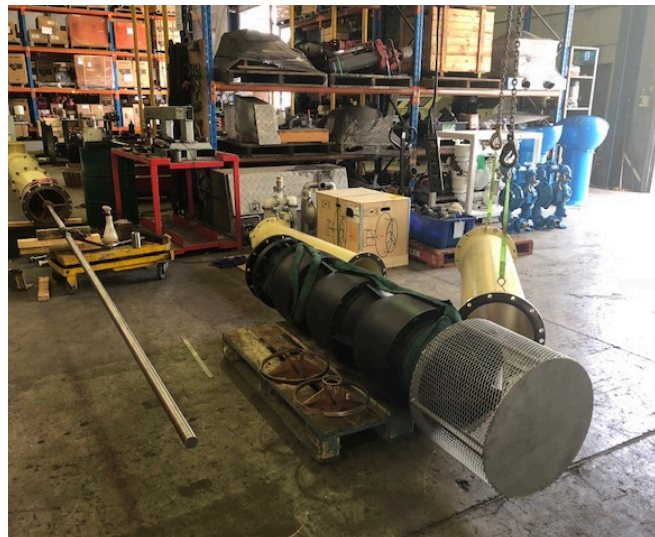
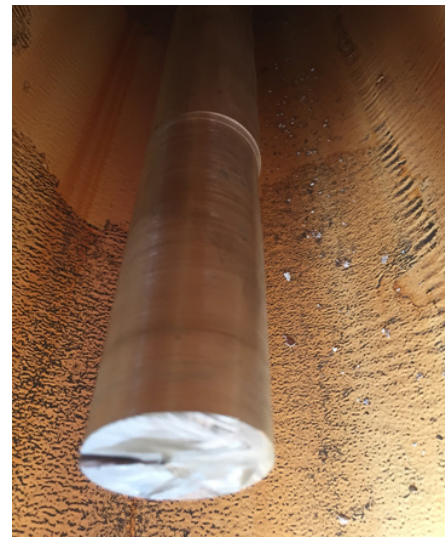
Dubbo Regional Councils essential town drinking water was serviced by a raw water intake Vertical Column Pump. This pump had suffered a critical failure due to a snapped shaft and considerable wear to the casing and impellers, caused by the constant ingress of river sand. On inspection, it was found pump 2 of 3 had failed.

Integrity Pumps orchestrated removal of the pump from site, a major overhaul and then successfully completed the delivery and re-installation.

The pump station operates 24/7, drawing from a river and discharging to a water treatment plant. The 220KW Column pump had a total of 10 sections totalling a 20m column and shaft length. There was a major drop in Q flow performance and a large rise in power consumption due to the wear on the impeller and snapped shaft.

Integrity Pumps managed and coordinated the appropriate crane and truck to provide safe removal and transportation of the pump. A major overhaul was completed in our workshop located in Unanderra NSW. On completion, the re-installation on the pump was completed successfully. The performance and efficiency of the pump has now increased resulting in reduced power consumption and reliable operations.
